Wind Mitigation Report
752 Landover Circle
Naples, FL

Uniform Mitigation Verification Inspection Form

Inspection Date: 5/18/2020		
Owner Information		
Owner Name: Newcastle Condo Association C/O Vesta		Contact Person: Denise Kosmala. CAM
Address: 752 Landover Circle		Home Phone:
City: Naples	Zip: 34104	Work Phone: 239-747-7227
County: Collier		Cell Phone:
Insurance Company: NA		Policy #:
Year of Home: 1991	# of Stories: 2	Email: dkosmala@vestapropertyservices.com

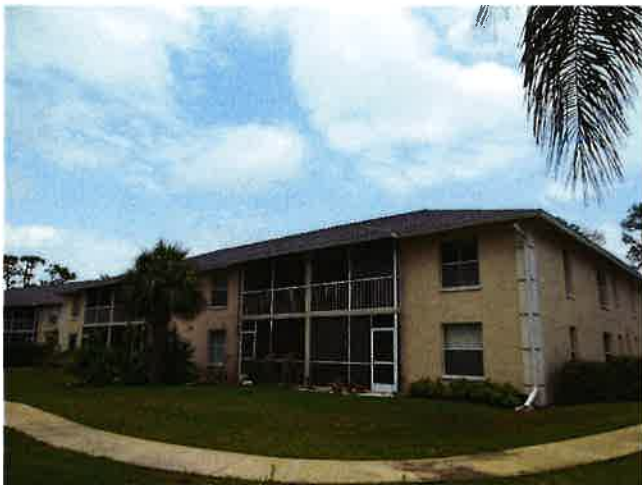
Rear Elevation

- X A. Hip Roof Hip roof with no other roof shapes greater than 10% of the total roof system perimeter.
Total length of non-hip features: 0 feet; Total roof system perimeter: 370 feet
- B. Flat Roof Roof on a building with 5 or more units where at least 90% of the main roof area has a roof slope of less than 2:12. Roof area with slope less than 2:12 _____ sq ft; Total roof area _____ sq ft
- C. Other Roof Any roof that does not qualify as either (A) or (B) above.

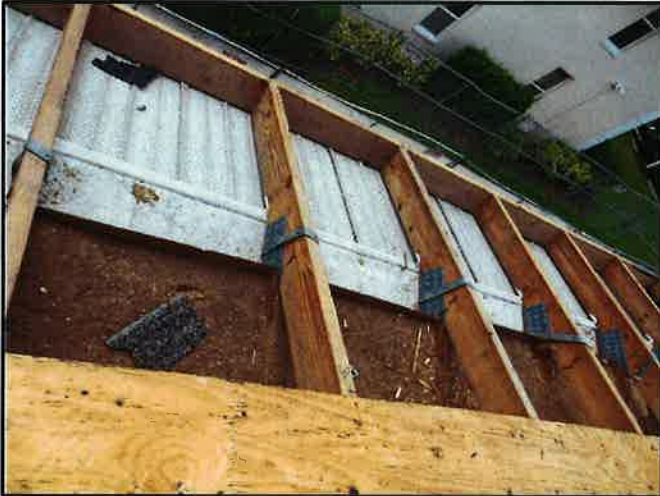
Truss Strapping

- X C. Single Wraps
 - Metal connectors consisting of a single strap that wraps over the top of the truss/rafter and is secured with a minimum of 2 nails on the front side and a minimum of 1 nail on the opposing side.

From April 1, 2020 until June 1, 2020, the complete Newcastle Condominium complex underwent a complete reroof project. The entire roof and underlayment were removed. Roof to wall attachments were exposed by removing the plywood and inspected. The truss strapping was inspected and reinforced by adding additional nails or Simpson HGAM Gusset angles where required. Damaged plywood was removed and replaced and all plywood was back nailed using 8d ring shank nails at 6" on center. The new peel & stick underlayment was installed and 30-year asphalt shingles applied using 6 nails. This reroof process was observed and monitored by ORCO's structural engineer.

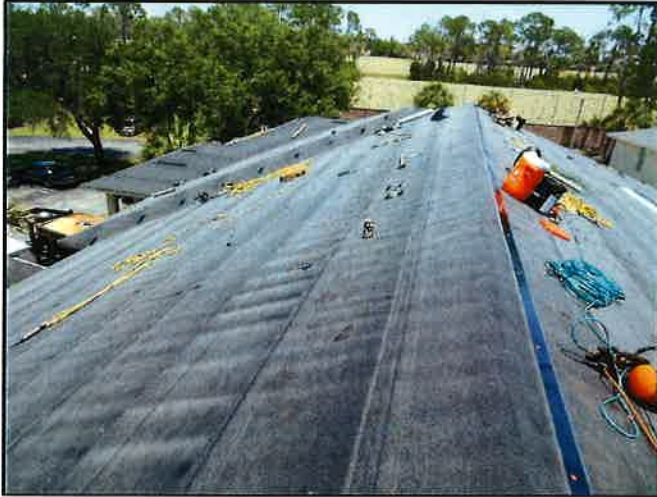
Underlayment

- X A. SWR (also called Sealed Roof Deck) Self-adhering polymer modified-bitumen roofing underlayment applied directly to the sheathing or foam adhesive SWR barrier (not foamed-on insulation) applied as a supplemental means to protect the dwelling from water intrusion in the event of roof covering loss.
- B. No SWR.
- C. Unknown or undetermined.

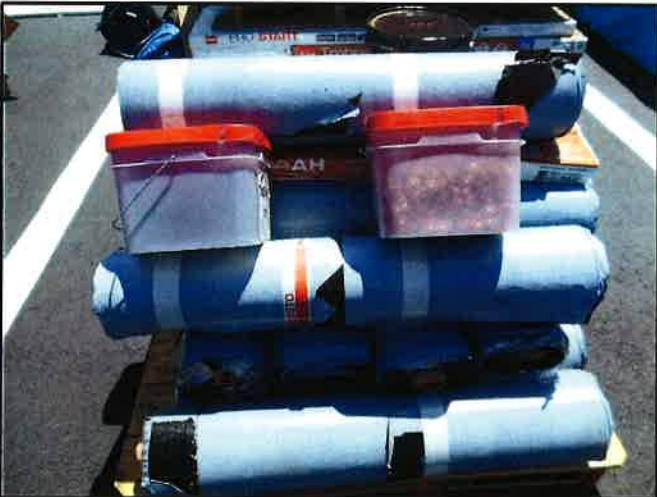
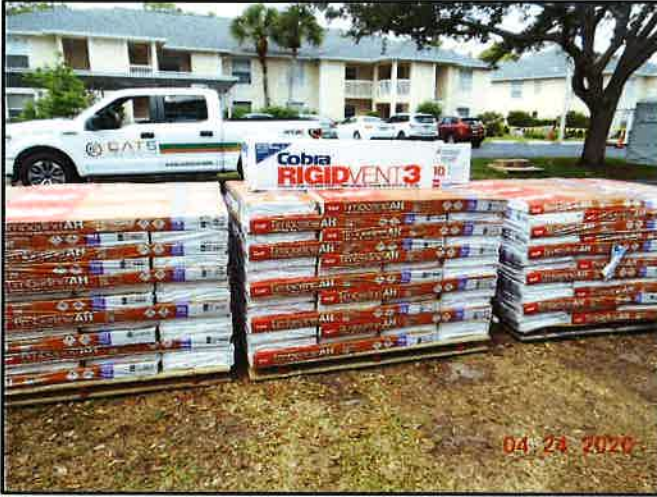
Asphalt Shingles

2.1 Roof Covering Type:	Permit Application Date	FBC or MDC Product Approval #	Year of Original Installation or Replacement	No Information Provided for Compliance
<input checked="" type="checkbox"/> 1 Asphalt/Fiberglass Shingle	03/26/2020	FL 10124-R25	2020	<input type="checkbox"/>
<input type="checkbox"/> 2 Concrete/Clay Tile	_____	_____	_____	<input type="checkbox"/>
<input type="checkbox"/> 3 Metal	_____	_____	_____	<input type="checkbox"/>
<input type="checkbox"/> 4 Built Up	_____	_____	_____	<input type="checkbox"/>
<input type="checkbox"/> 5 Membrane	_____	_____	_____	<input type="checkbox"/>
<input type="checkbox"/> 6 Other _____	_____	_____	_____	<input type="checkbox"/>
