# **Wind Mitigation Report**

**605 Squire Circle  
Naples, FL**

**June 2, 2020**

## Uniform Mitigation Verification Inspection Form

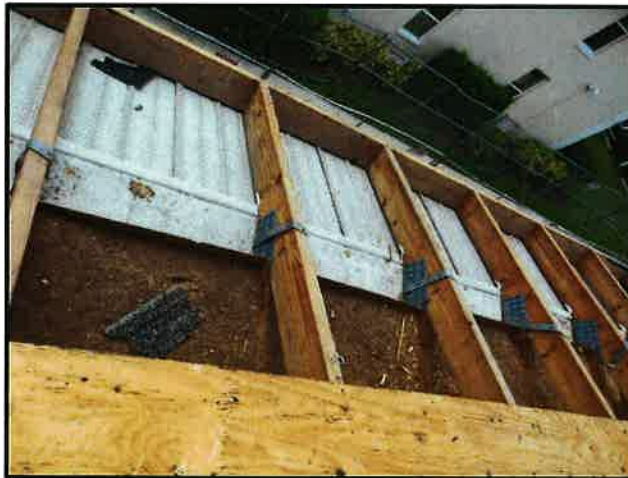
**Truss Strapping**

Metal connectors consisting of a single strap that wraps over the top of the truss/rafter and is secured with a minimum of 2 nails on the front side and a minimum of 1 nail on the opposing side.

From April 1, 220 until June 1, 2020, the complete Newcastle Condominium complex underwent a complete reroof project. The entire roof and underlayment were removed. Roof to wall attachments were exposed by removing the plywood and inspected. The truss strapping was inspected and reinforced by adding additional nails or Simpson HGAM Gusset angles where required. Damaged plywood was removed and replaced and all plywood was back nailed using 8d ring shank nails at 6" on center. The new peel & stick underlayment was installed and 30-year asphalt shingles applied using 6 nails. This reroof process was observed and monitored by ORCO's structural engineer.

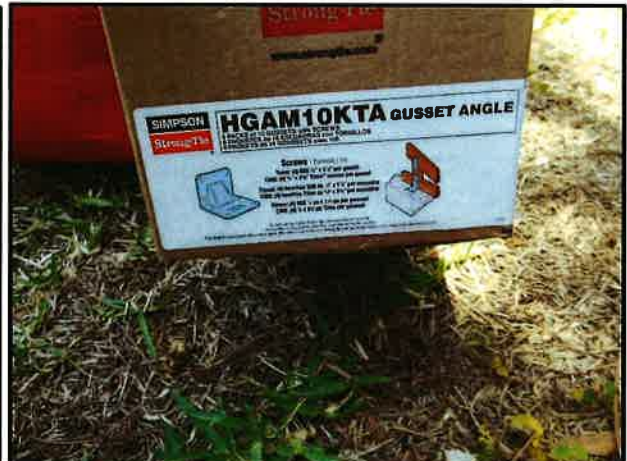
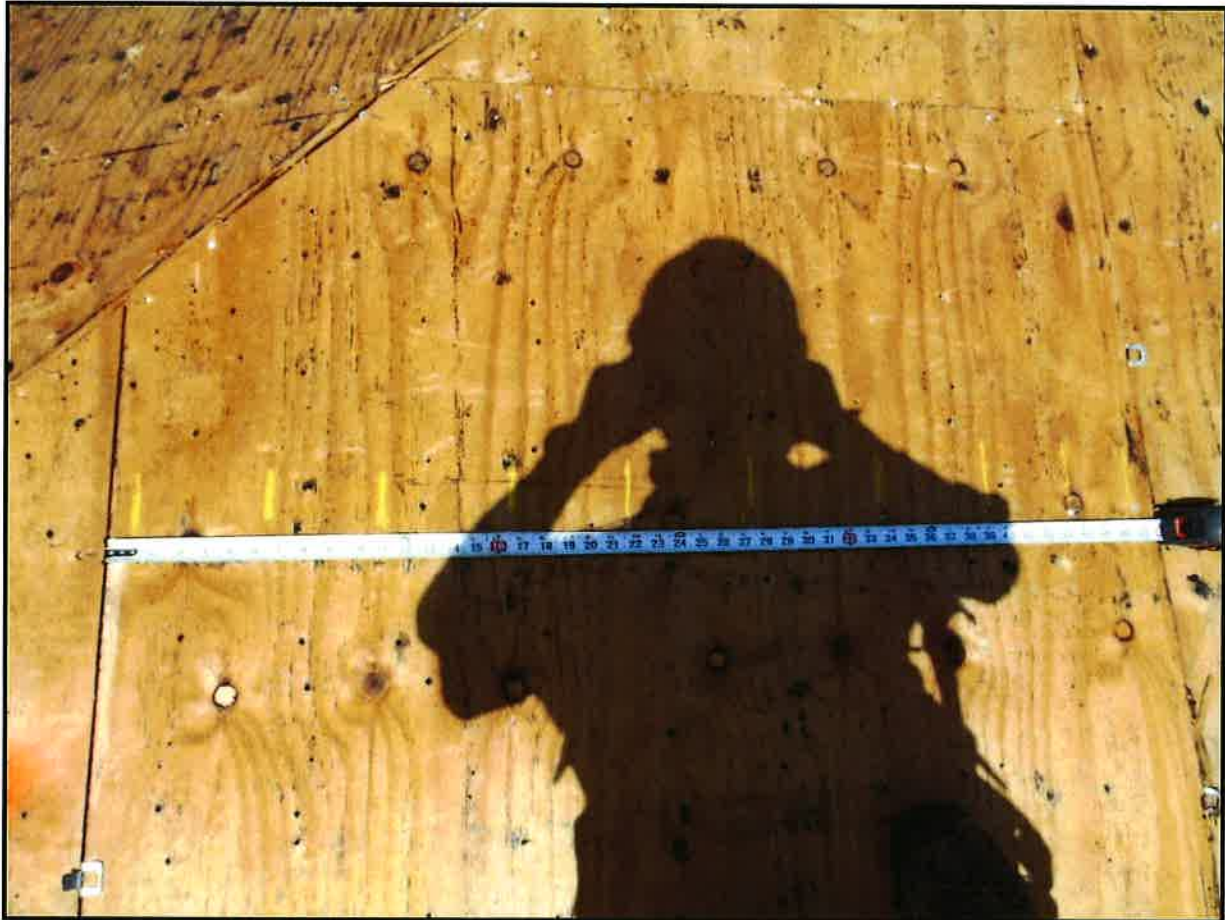
**Plywood Nailing**

- ☒ C. Plywood/OSB roof sheathing with a minimum thickness of 7/16" inch attached to the roof truss/rafter (spaced a maximum of 24" inches o.c.) by 8d common nails spaced a maximum of 6" inches in the field. -OR- Dimensional lumber/Tongue & Groove decking with a minimum of 2 nails per board (or 1 nail per board if each board is equal to or less than 6 inches in width). -OR- Any system of screws, nails, adhesives, other deck fastening system or truss/rafter spacing that is shown to have an equivalent

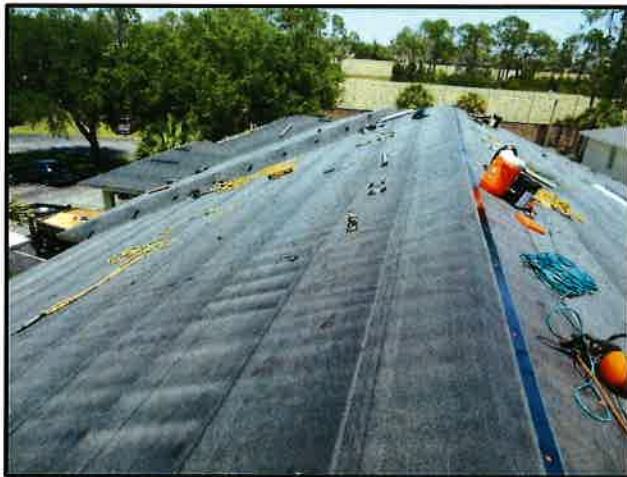
**Underlayment**

☒ A. SWR (also called Sealed Roof Deck) Self-adhering polymer modified-bitumen roofing underlayment applied directly to the sheathing or foam adhesive SWR barrier (not foamed-on insulation) applied as a supplemental means to protect the dwelling from water intrusion in the event of roof covering loss.

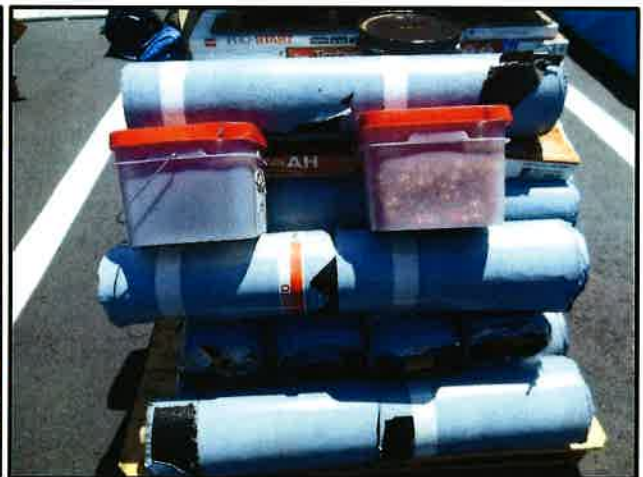
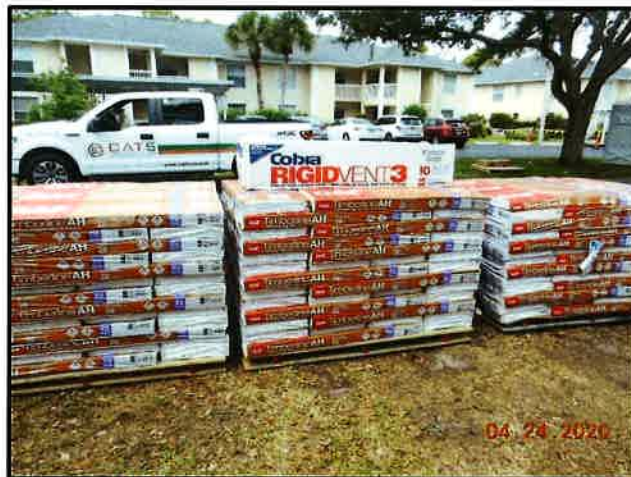
**Asphalt Shingles**

| 2.1 Roof Covering Type: | Permit Application Date | FBC or MDC Product Approval # | Year of Original Installation or Replacement | No Information Provided for Compliance |
|---|---|---|---|---|
| <input checked="" type="checkbox"/> 1. Asphalt/Fiberglass Shingle | 03/26/2020 | FL 10124-R25 | 2020 | <input type="checkbox"/> |
