Wind Mitigation Report

**662 Squire Circle
Naples, FL**

May 29, 2020

Uniform Mitigation Verification Inspection Form

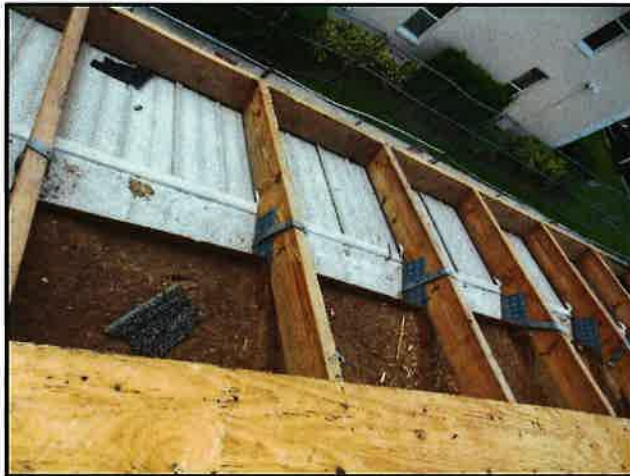
Truss Strapping

From April 1, 220 until June 1, 2020, the complete Newcastle Condominium complex underwent a complete reroof project. The entire roof and underlayment were removed. Roof to wall attachments were exposed by removing the plywood and inspected. The truss strapping was inspected and reinforced by adding additional nails or Simpson HGAM Gusset angles where required. Damaged plywood was removed and replaced and all plywood was back nailed using 8d ring shank nails at 6" on center. The new peel & stick underlayment was installed and 30-year asphalt shingles applied using 6 nails. This reroof process was observed and monitored by ORCO's structural engineer.
