# Wind Mitigation Report

685 Squire Circle  
Naples, FL

**June 2, 2020**

## Uniform Mitigation Verification Inspection Form

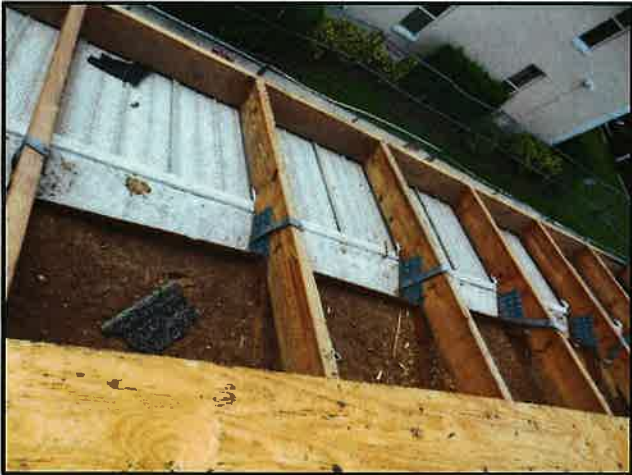
**Truss Strapping**

From April 1, 2020 until June 1, 2020, the complete Newcastle Condominium complex underwent a complete reroof project. The entire roof and underlayment were removed. Roof to wall attachments were exposed by removing the plywood and inspected. The truss strapping was inspected and reinforced by adding additional nails or Simpson HGAM Gusset angles where required. Damaged plywood was removed and replaced and all plywood was back nailed using 8d ring shank nails at 6" on center. The new peel & stick underlayment was installed and 30-year asphalt shingles applied using 6 nails. This reroof process was observed and monitored by ORCO's structural engineer.
