# **Wind Mitigation Report**

**686 Squire Circle  
Naples, FL**

**June 2, 2020**

## Uniform Mitigation Verification Inspection Form

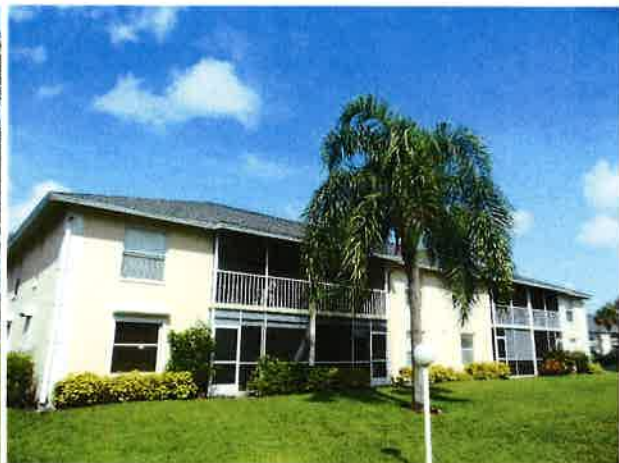
**Rear Elevation**

☒ A. Hip Roof Hip roof with no other roof shapes greater than 10% of the total roof system perimeter.

Total length of non-hip features: 0 feet; Total roof system perimeter: 370 feet

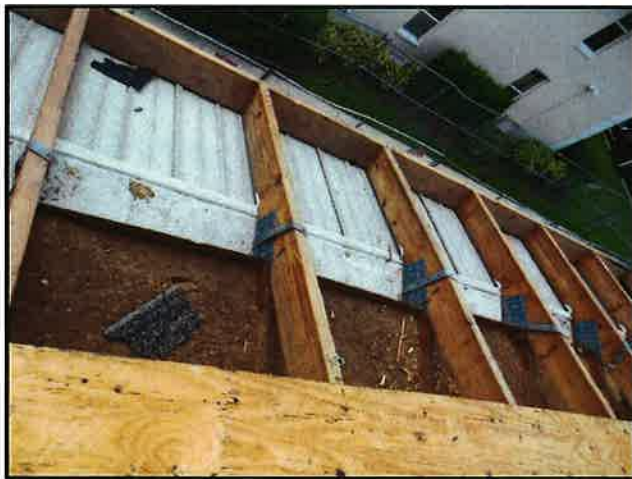
**Truss Strapping**

☒ C. Single Wraps

Metal connectors consisting of a single strap that wraps over the top of the truss/rafter and is secured with a minimum of 2 nails on the front side and a minimum of 1 nail on the opposing side.

From April 1, 220 until June 1, 2020, the complete Newcastle Condominium complex underwent a complete reroof project. The entire roof and underlayment were removed. Roof to wall attachments were exposed by removing the plywood and inspected. The truss strapping was inspected and reinforced by adding additional nails or Simpson HGAM Gusset angles where required. Damaged plywood was removed and replaced and all plywood was back nailed using 8d ring shank nails at 6" on center. The new peel & stick underlayment was installed and 30-year asphalt shingles applied using 6 nails. This reroof process was observed and monitored by ORCO's structural engineer.

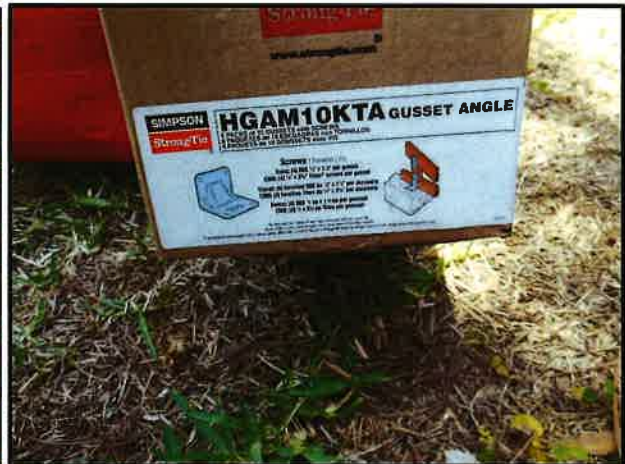
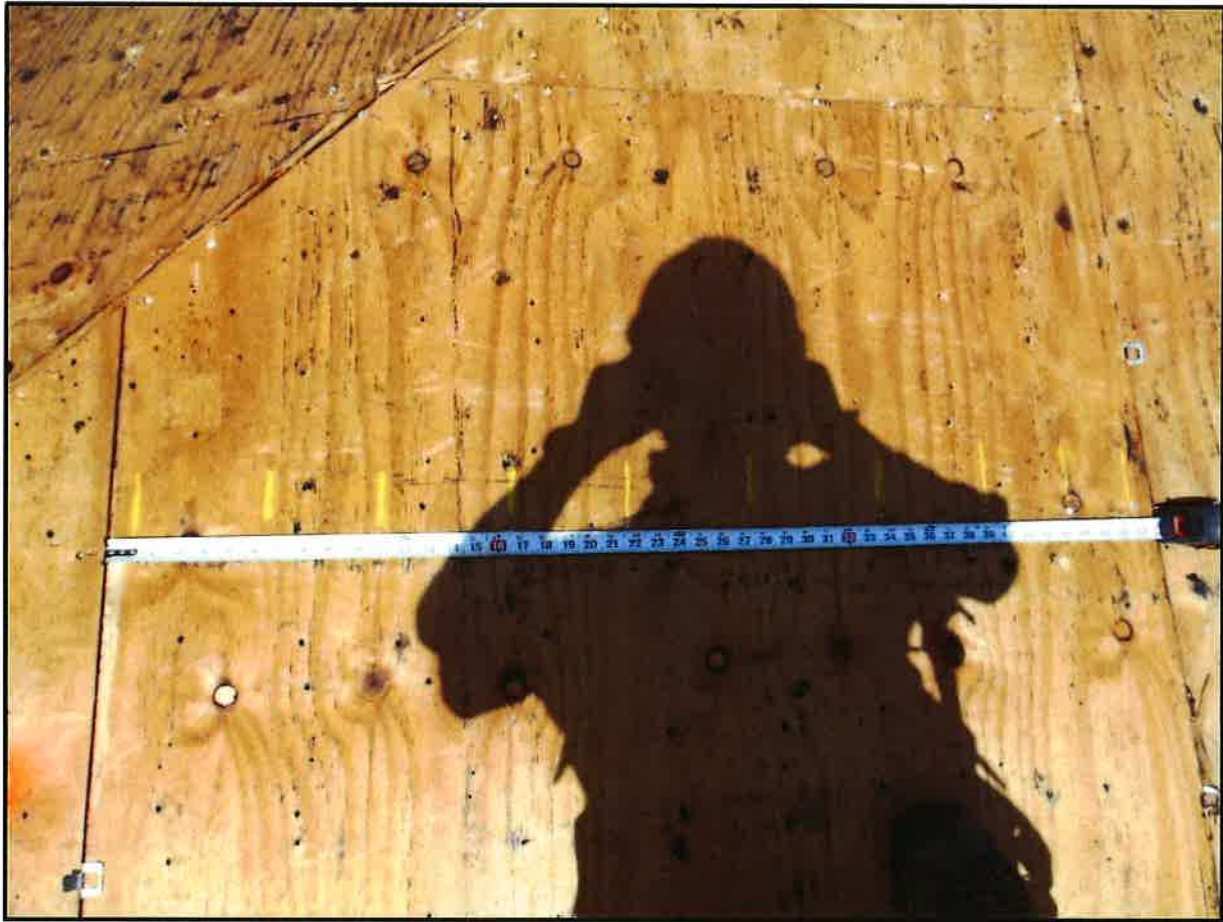
**Plywood Nailing**

☒ C. Plywood/OSB roof sheathing with a minimum thickness of 7/16" inch attached to the roof truss/rafter (spaced a maximum of 24" inches o.c.) by 8d common nails spaced a maximum of 6" inches in the field. -OR- Dimensional lumber/Tongue & Groove decking with a minimum of 2 nails per board (or 1 nail per board if each board is equal to or less than 6 inches in width). -OR- Any system of screws, nails, adhesives, other deck fastening system or truss/rafter spacing that is shown to have an equivalent

or greater resistance than 8d common nails spaced a maximum of 6 inches in the field or has a mean uplift resistance of at least 182 psf.

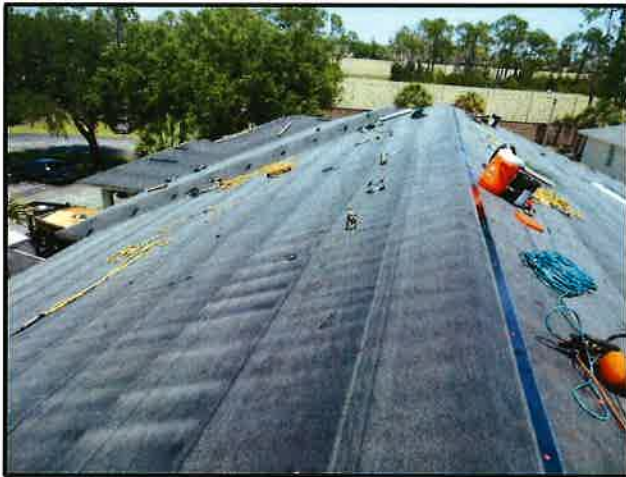
**Underlayment**

☒ A. SWR (also called Sealed Roof Deck) Self-adhering polymer modified-bitumen roofing underlayment applied directly to the sheathing or foam adhesive SWR barrier (not foamed-on insulation) applied as a supplemental means to protect the dwelling from water intrusion in the event of roof covering loss.

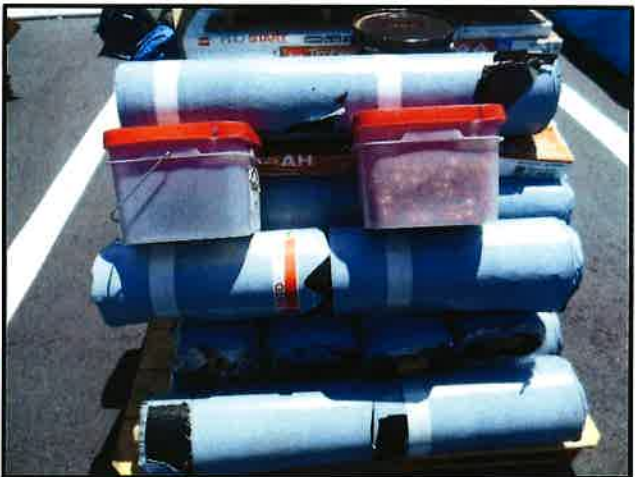
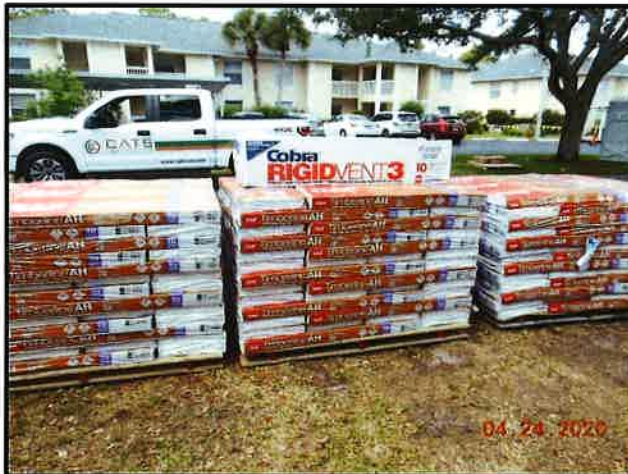
**Asphalt Shingles**

| 2.1 Roof Covering Type: | Permit Application Date | FBC or MDC Product Approval # | Year of Original Installation or Replacement | No Information Provided for Compliance |
|---|---|---|---|---|
| <input checked="" type="checkbox"/> 1. Asphalt/Fiberglass Shingle | 03/26/2020 | FL 10124-R25 | 2020 | <input type="checkbox"/> |
