# **Wind Mitigation Report**

**629 Squire Court  
Naples, FL**

**May 26, 2020**

## Uniform Mitigation Verification Inspection Form

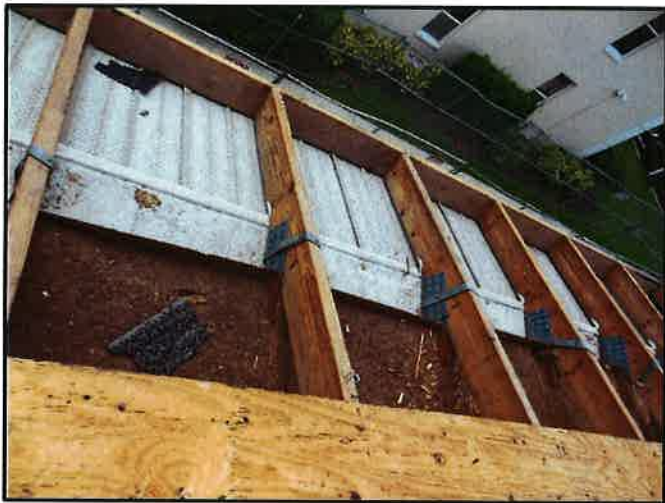
**Truss Strapping**

X ☒ C. Single Wraps

Metal connectors consisting of a single strap that wraps over the top of the truss/rafter and is secured with a minimum of 2 nails on the front side and a minimum of 1 nail on the opposing side.

From April 1, 220 until June 1, 2020, the complete Newcastle Condominium complex underwent a complete reroof project. The entire roof and underlayment were removed. Roof to wall attachments were exposed by removing the plywood and inspected. The truss strapping was inspected and reinforced by adding additional nails or Simpson HGAM Gusset angles where required. Damaged plywood was removed and replaced and all plywood was back nailed using 8d ring shank nails at 6" on center. The new peel & stick underlayment was installed and 30-year asphalt shingles applied using 6 nails. This reroof process was observed and monitored by ORCO's structural engineer.

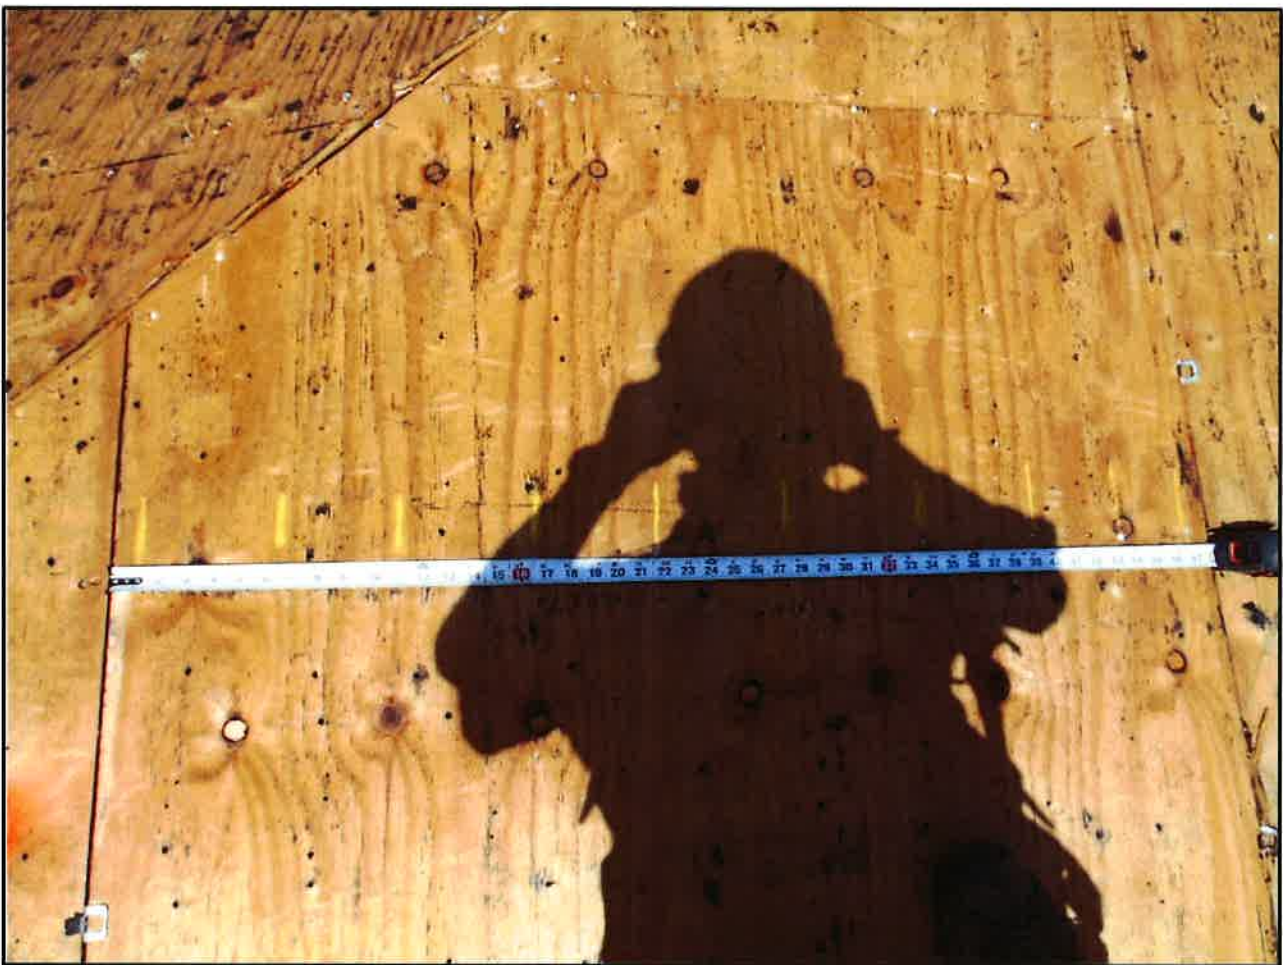
**Plywood Nailing**

- ☒ C. Plywood/OSB roof sheathing with a minimum thickness of 7/16" inch attached to the roof truss/rafter (spaced a maximum of 24" inches o.c.) by 8d common nails spaced a maximum of 6" inches in the field. -OR- Dimensional lumber/Tongue & Groove decking with a minimum of 2 nails per board (or 1 nail per board if each board is equal to or less than 6 inches in width). -OR- Any system of screws, nails, adhesives, other deck fastening system or truss/rafter spacing that is shown to have an equivalent

or greater resistance than 8d common nails spaced a maximum of 6 inches in the field or has a mean uplift resistance of at least 182 psf.

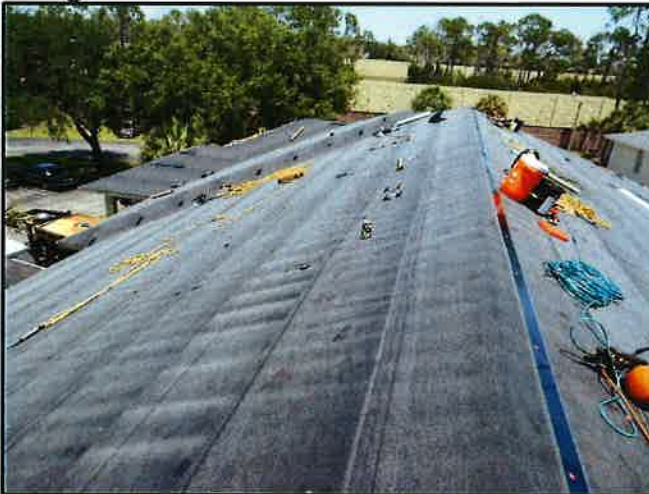
Underlayment

X ☒ A. SWR (also called Sealed Roof Deck) Self-adhering polymer modified-bitumen roofing underlayment applied directly to the sheathing or foam adhesive SWR barrier (not foamed-on insulation) applied as a supplemental means to protect the dwelling from water intrusion in the event of roof covering loss.

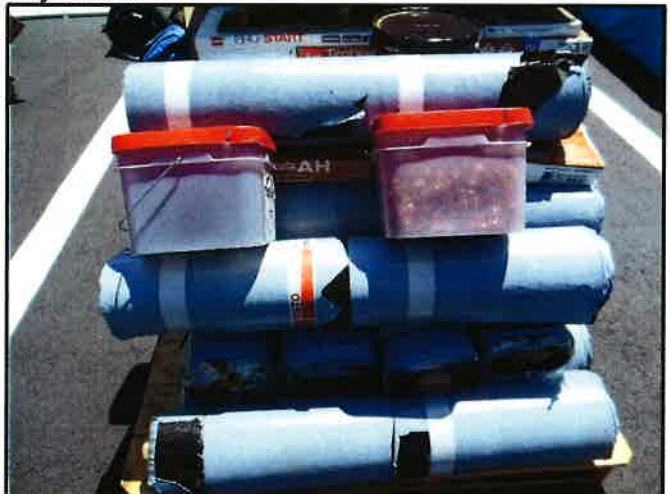
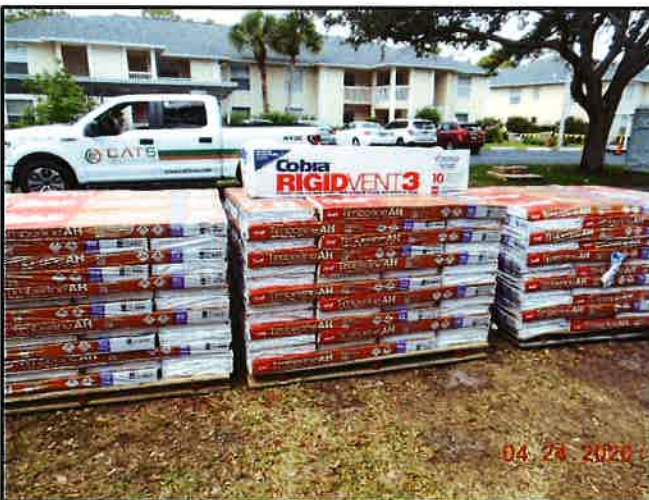
Asphalt Shingles

| 2.1 Roof Covering Type: | Permit Application Date | FBC or MDC Product Approval # | Year of Original Installation or Replacement | No Information Provided for Compliance |
|---|---|---|---|---|
| <input checked="" type="checkbox"/> 1. Asphalt/Fiberglass Shingle | 03/26/2020 | FL 10124-R25 | 2020 | <input type="checkbox"/> |
