# **Wind Mitigation Report**

**637 Squire Court  
Naples, FL**

**May 26, 2020**

## Uniform Mitigation Verification Inspection Form

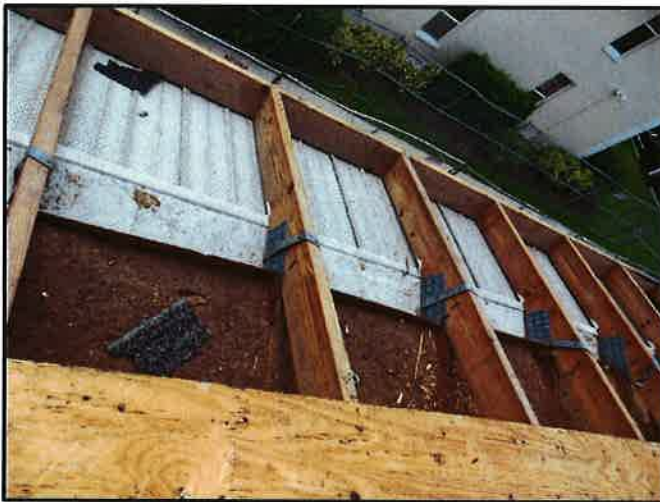
**Truss Strapping**

X C. Single Wraps

Metal connectors consisting of a single strap that wraps over the top of the truss/rafter and is secured with a minimum of 2 nails on the front side and a minimum of 1 nail on the opposing side.

From April 1, 220 until June 1, 2020, the complete Newcastle Condominium complex underwent a complete reroof project. The entire roof and underlayment were removed. Roof to wall attachments were exposed by removing the plywood and inspected. The truss strapping was inspected and reinforced by adding additional nails or Simpson HGAM Gusset angles where required. Damaged plywood was removed and replaced and all plywood was back nailed using 8d ring shank nails at 6" on center. The new peel & stick underlayment was installed and 30-year asphalt shingles applied using 6 nails. This reroof process was observed and monitored by ORCO's structural engineer.

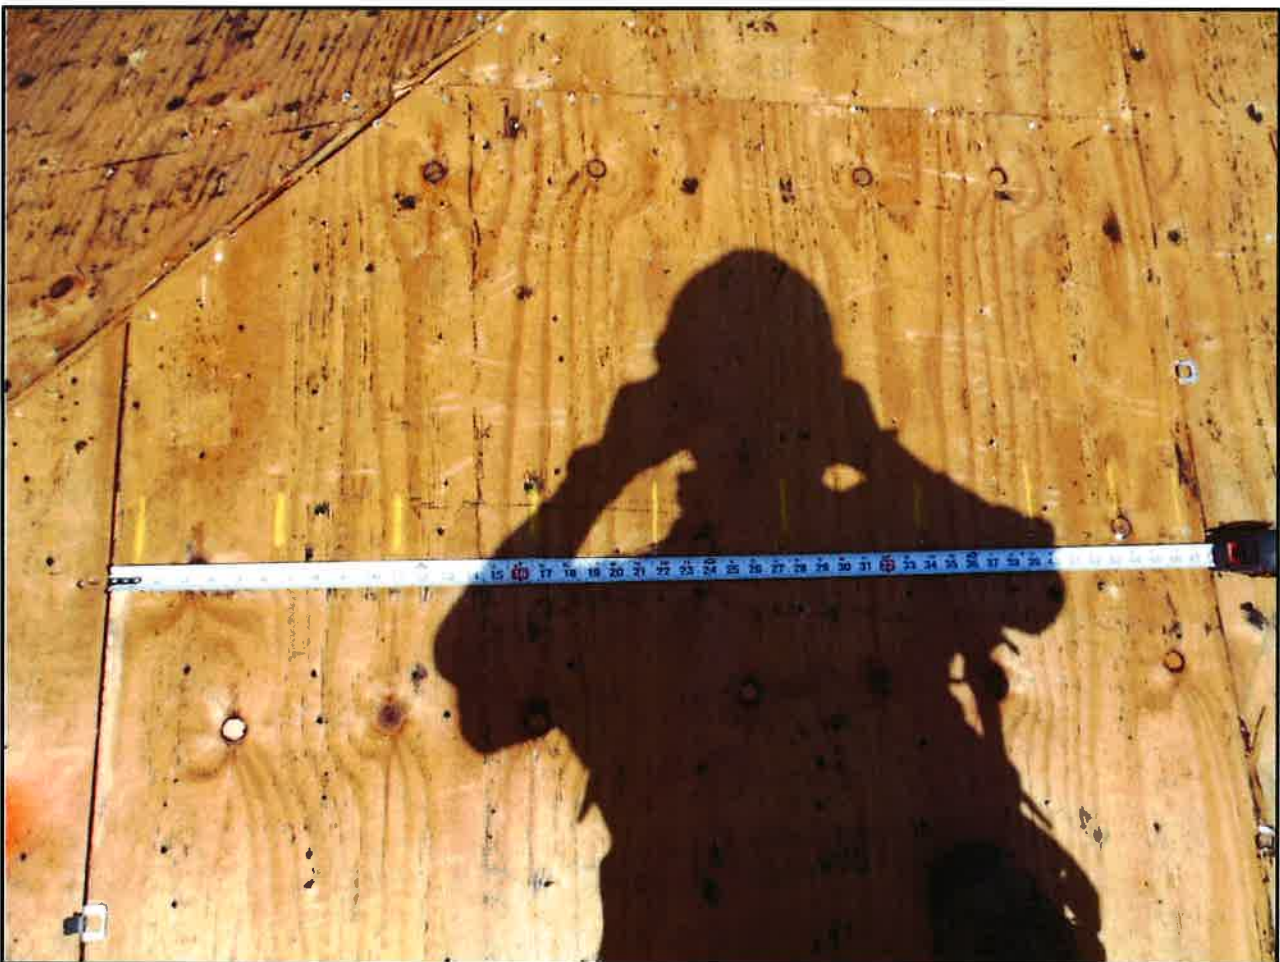
**Plywood Nailing**

- ☒ C. Plywood/OSB roof sheathing with a minimum thickness of 7/16" inch attached to the roof truss/rafter (spaced a maximum of 24" inches o.c.) by 8d common nails spaced a maximum of 6" inches in the field. -OR- Dimensional lumber/Tongue & Groove decking with a minimum of 2 nails per board (or 1 nail per board if each board is equal to or less than 6 inches in width). -OR- Any system of screws, nails, adhesives, other deck fastening system or truss/rafter spacing that is shown to have an equivalent

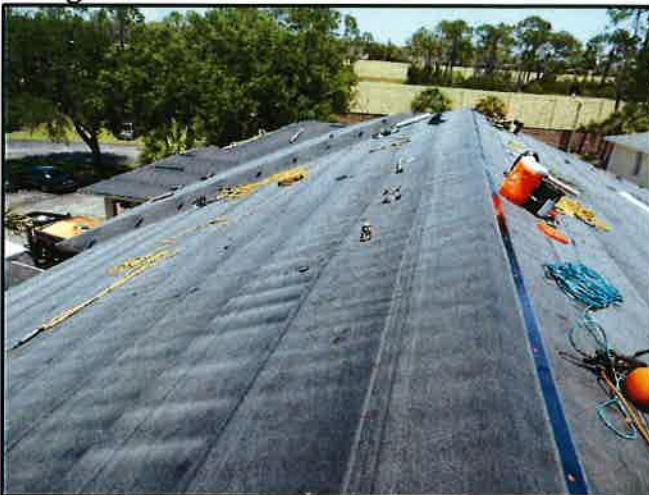
Underlayment

X A. SWR (also called Sealed Roof Deck) Self-adhering polymer modified-bitumen roofing underlayment applied directly to the sheathing or foam adhesive SWR barrier (not foamed-on insulation) applied as a supplemental means to protect the dwelling from water intrusion in the event of roof covering loss.

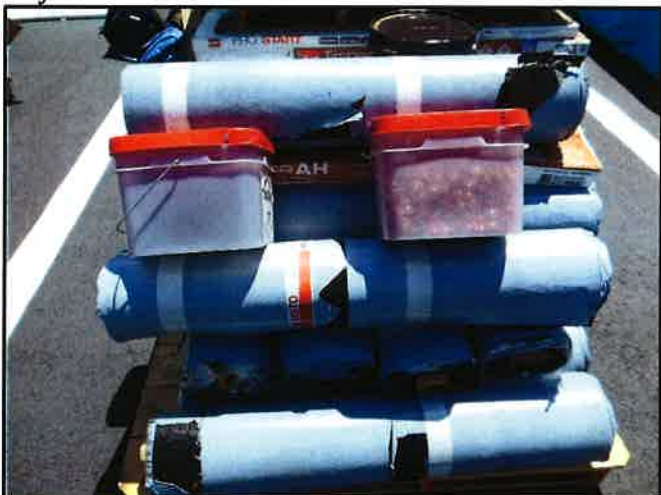
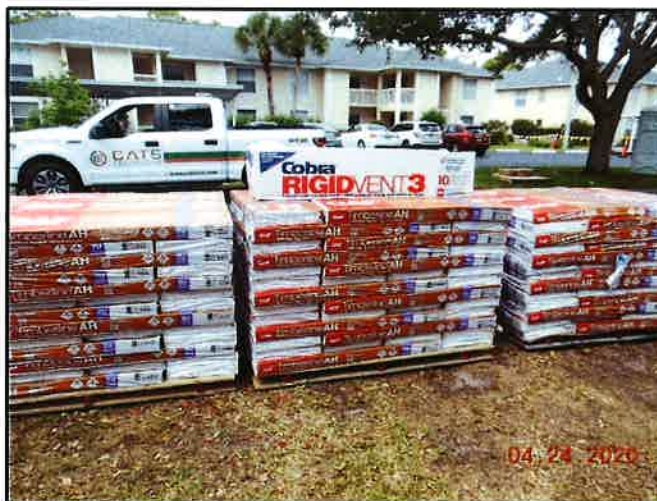
Asphalt Shingles

| 2.1 Roof Covering Type: | Permit Application Date | FBC or MDC Product Approval # | Year of Original Installation or Replacement | No Information Provided for Compliance |
|---|---|---|---|---|
| <input checked="" type="checkbox"/> 1. Asphalt/Fiberglass Shingle | 03/26/2020 | FL 10124-R25 | 2020 | <input type="checkbox"/> |
